# IC-7000 Sendeleistung zu gering

Selbsterregung der Treiberstufe bei älteren IC-7000

## IC-7000 driver amplifier self-oscillation problem.

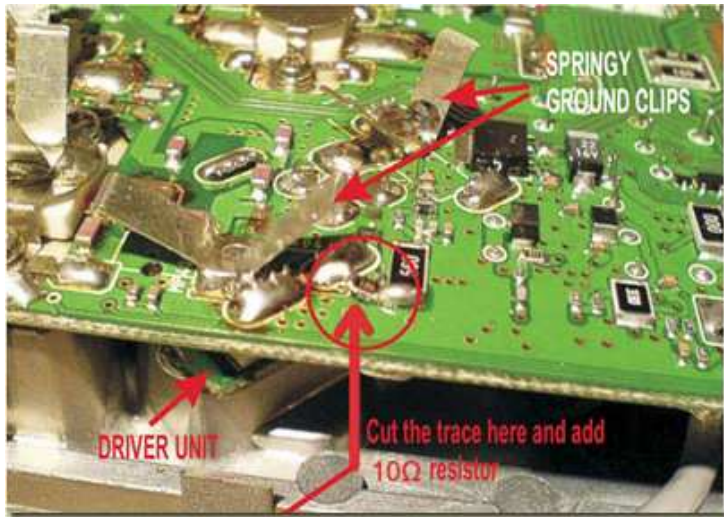
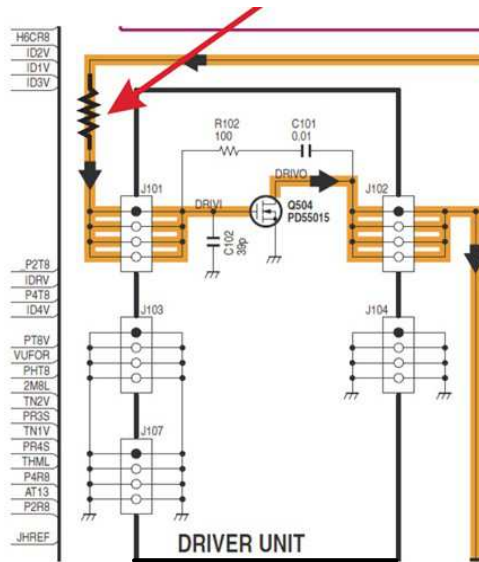
Leiterbahn unterbrechen und  
10 Ohm SMD Widerstand einfügen.

**THEORY OF OPERATION:** This mod lowers the Q of the copper trace circuits feeding the driver amplifier's input, therefore quenching any tendency of the stage to self-oscillate at some VHF frequency, with destructive results.

**IMPLEMENTATION:** After removing the covers, locate the driver unit's input trace (SEE PHOTO), cut it carefully and scrape the solder resistant enamel to expose the copper surface. Then, solder an 10 Ohm (or so...) SMD resistor across the cut of the PCB. That's all!
